Aircraft Accident Report - L and J
Company, Convair 240, N55VM,
Gillsburg, Mississippi, October 20, 1977

1. Report No. NTSB-AAR-78-6	2. Government Accession No.	3. Recipient's Catalog No.	
4. Title and Subtitle Aircraft Accident Report -- L & J Company, Convair 240, N55VM, Gillsburg, Mississippi, October 20, 1977		5. Report Date June 19, 1978	
		6. Performing organization Code	
7. Author(s)		8. Performing Organization Report No.	
9. Performing Organization Name and Address National Transportation Safety Board Bureau of Accident Investigation Washington, D.C. 20594		10. Work Unit No. 2365	
		11. Contract or Grant No.	
12. Sponsoring Agency Name and Address NATIONAL TRANSPORTATION SAFETY BOARD Washington, D. C. 20594		13. Type of Report and Period Covered Aircraft Accident Report October 20, 1977	
		14. Sponsoring Agency Code	
15. Supplementary Notes

AIRCRAFT ACCIDENT REPORT

L & J COMPANY
CONVAIR 240, N55VM
GILLSBURG, MISSISSIPPI
OCTOBER 20, 1977

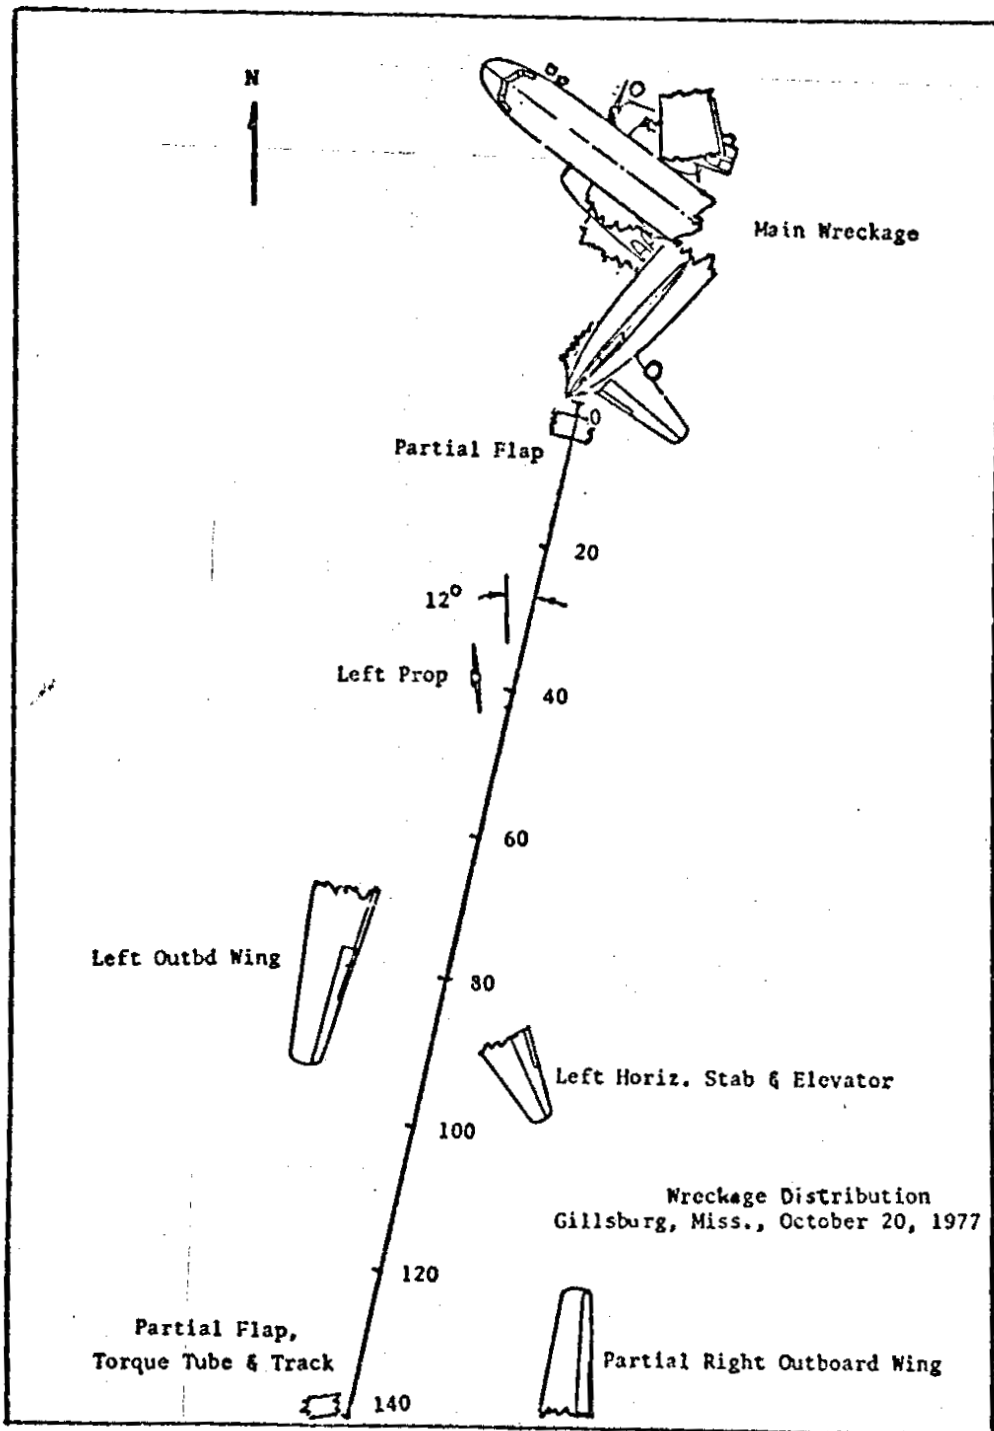
APPENDIX D

after the aircraft hit the second tree and continued the steeper angle until it hit the ground. The wreckage path was about 495 ft long. Trees as high as 80 ft and as large as 3 ft in diameter were struck during the final 300 ft of flight. The left horizontal Stabilizer and the outboard section of both wings were torn from the aircraft and found 100 ft from the main wreckage along the wreckage path. The right outboard wing pane' separated from the aircraft after initial contact with trees. The left horizontal stabilizer and the left outboard wing panel also struck trees and separated along the wreckage path. The wreckage distribution was on a magnetic heading of 012'. The fuselage continued forward on that heading and came to rest about 140 ft from the point of initial impact. The fuselage separated forward of the bottom leading edge of the vertical stabilizer. The center wing and engine nacelles were twisted to the left of the forward fuselage. The cockpit structure was crushed against trees. Cabin seats separated during the impact sequence. (Pee. Appendix D.)
